## CERVICAL SPINAL CORD STIMULATOR MALFUNCTION SECONDARY TO LEAD FRACTURE

**Background:** Spinal cord stimulation (SCS) is commonly used in the cervical spine to manage chronic intractable pain. However, complications can include lead displacement, lead migration, and lead fracture.

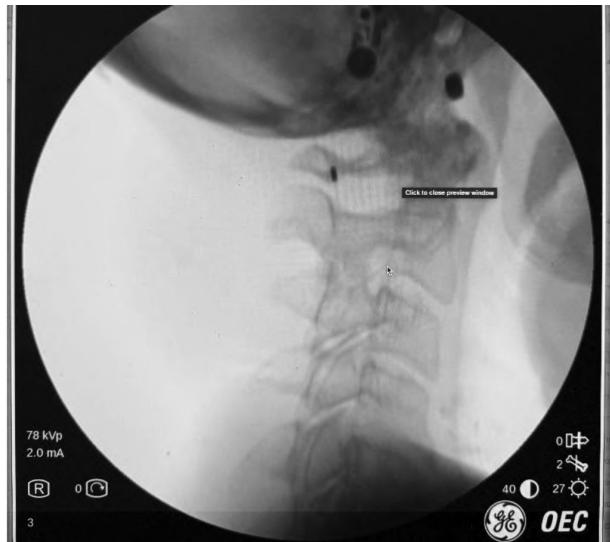
Fig. 4. Fluoroscopic lateral image after explantation with retained electrode.

Postoperative imaging, however, revealed that the distal electrode tip of one lead remained in the cervical epidural space (Figs. 3-5). This was deemed an abandoned lead. Although surgical removal is the definitive treatment, technical support advised that an MRI of the brain could still be performed as long as the retained fragment lies outside the imaging coil field.

In the second case, the spinal cord stimulator was malfunctioning. Preoperative fluoroscopic imaging did not reveal any dislocation or fracture of the electrode; however, a retained distal electrode fragment was identified intraoperatively during explantation. Due to the risks associated with further surgery, the patient declined additional intervention to remove the residual lead.

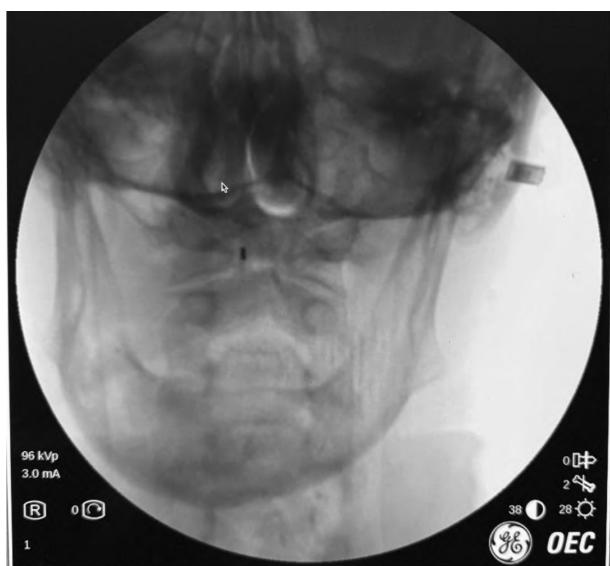
Fig. 5. Fluoroscopic PA view with retained electrode post explantation.
